Postoperative bilateral knee prosthesis exposure due to trauma

Posttraumatic bilateral knee prosthesis exposure

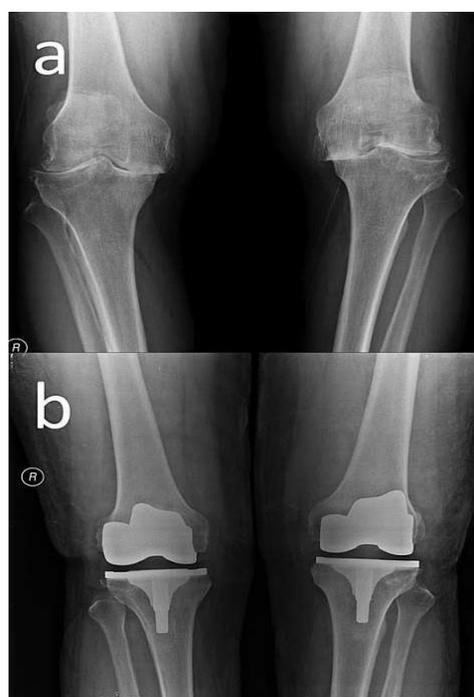
A 67-year old male patient underwent simultaneous bilateral total knee arthroplasty for bilateral knee osteoarthritis (Fig. 1a, b). During the 10 day postoperative hospitalization period, daily wound dressings, mobilization, and a rehabilitation program were applied until both knees could achieve 90° flexion, at which point he was discharged. On the 17th day after the operation, he was hospitalized again having had a fall.

Fig. 1. Preoperative and postoperative bilateral knee radiographies of the patient

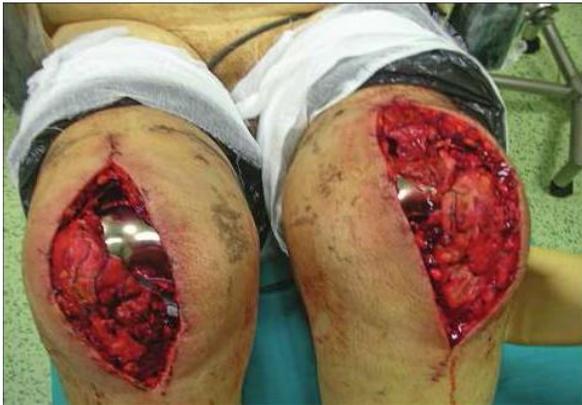
The patient's physical examination on his admittance revealed bilateral wound dehiscence of skin, subcutaneous tissue, and median arthrotomy sutures. Both prostheses were exposed (Fig. 2). The patient was taken to the operating theater immediately and was examined under anesthesia. A physical examination showed dehiscence of all sutures and stress tests revealed medial right knee, and lateral left knee collateral ligament ruptures.

Fig. 2. Exposition of bilateral prostheses

Both knees were irrigated vigorously with saline and the old sutures were removed and debridement was performed. The prosthetic inserts were changed for constrained inserts for medial and lateral instabilities and the prosthetic stabilities were rechecked. Further surgery was not required. Following the operation, the medication used was cefazolin. On postoperative day 1, he was mobilized and active and passive motion exercises were started. On the 3rd day he was taken to the operating room because drainage occurred on the right knee. Debridement and irrigation were again applied. He was discharged 6 days later. He was followed up with a physical examination, laboratory parameters (C reactive protein, erythrocyte sedimentation rate, white blood cells), and x-rays in the 3rd, 6th, 9th and 12th months. The final examination revealed no erythema, tenderness, or any positive infection parameters. Laboratory parameters were normal. There were no abnormalities on the x-rays. There was no mediolateral instability, flexion was 90° and extension was neutral at 0 degrees.
